## BELZONA SOLUTIONS KEEPING SAILORS DRY

### BELZONA OFFICES, DISTRIBUTORS AND PARTNERS COMBINE FOR DSV REPAIR PROJECT

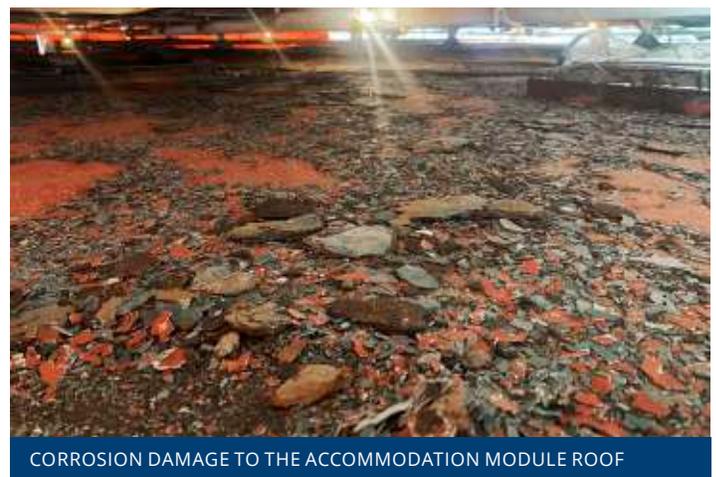
The vessel was suffering from serious **pitting** and **corrosion** on the roof resulting in persistent leaks into the accommodation module. Although the vessel was in dry dock at the **Baku Shipyard**, access to the damaged roof was difficult as it was directly underneath the helideck. Initial consideration by the client was to replace the whole roof, however, this would involve removing the helideck above and with such a short time frame to complete the repairs this was not a viable option.

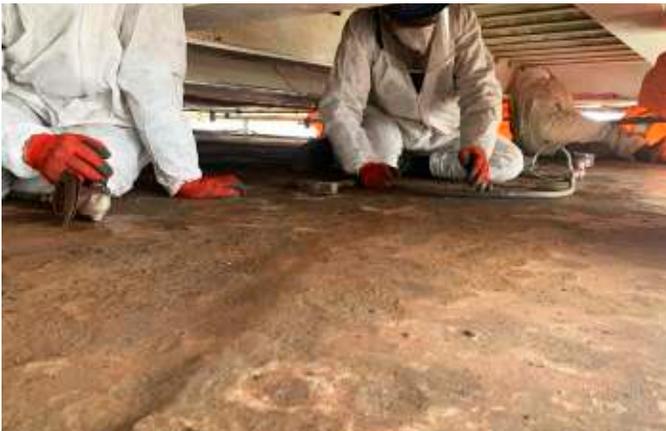
SURFACE PREPARATION OF THE ROOF AREA

To prepare the surface for application, the team removed all the loose rust, paint and other debris with hard scrapers, chipping hammers, chisels and grinders. The entire substrate was then cleaned with **Belzona 9111 Cleaner/Degreaser**. **Belzona 1161** was mixed and applied to the pitted areas and further applications of **Belzona 1161** were made to ensure the pits were completely filled and that no bridging over holed areas had occurred.

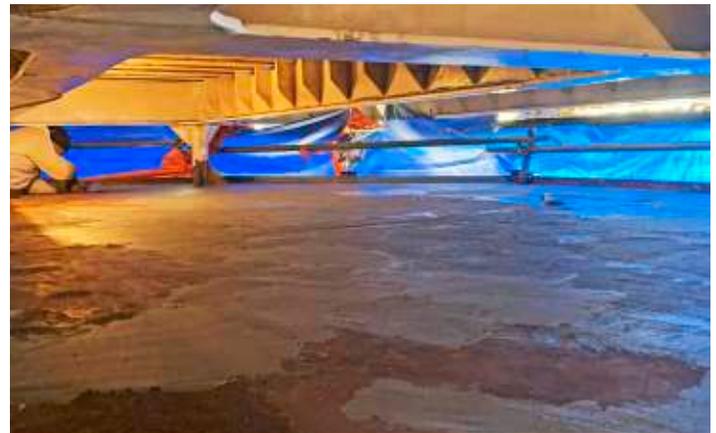
BELZONA 1161 APPLIED TO THE DAMAGED AREAS OF THE ROOF

Each of the damaged areas was smoothed out with Belzona applicators to ensure no bumps or ridges remained for the subsequent overcoating with **Belzona 5831**. After the **Belzona 1161** application had fully cured, the application team used short bristle brushes to apply the first coat of **Belzona 5831** and then applied a layer of **Belzona 9341** reinforcement sheet.

The second coat of **Belzona 5831** was then applied and paint rollers were used to smooth out the surface and complete the application. For the more severely damaged areas of the roof which included cracks and through holes, prefabricated steel patch plates were bonded to the substrate with **Belzona 1161** before the applications of **Belzona 5831**.

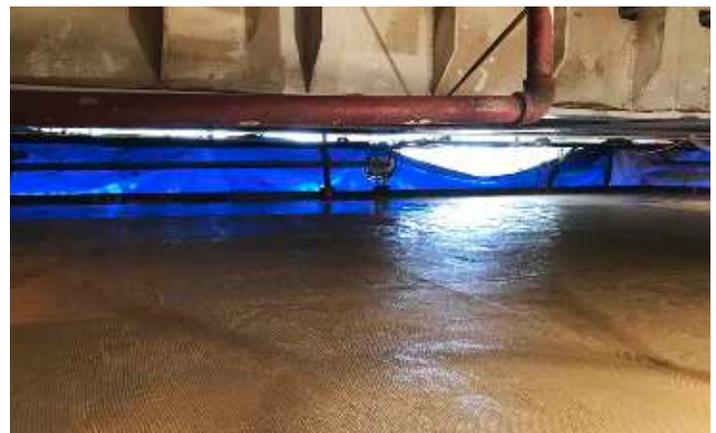
APPLICATION COMPLETED WITH FINAL COAT OF BELZONA 5831
